Glen Echo Drive Ravine Sedimentation Study

City of Grand Rapids

HRC Project No. 20180827

December 2018

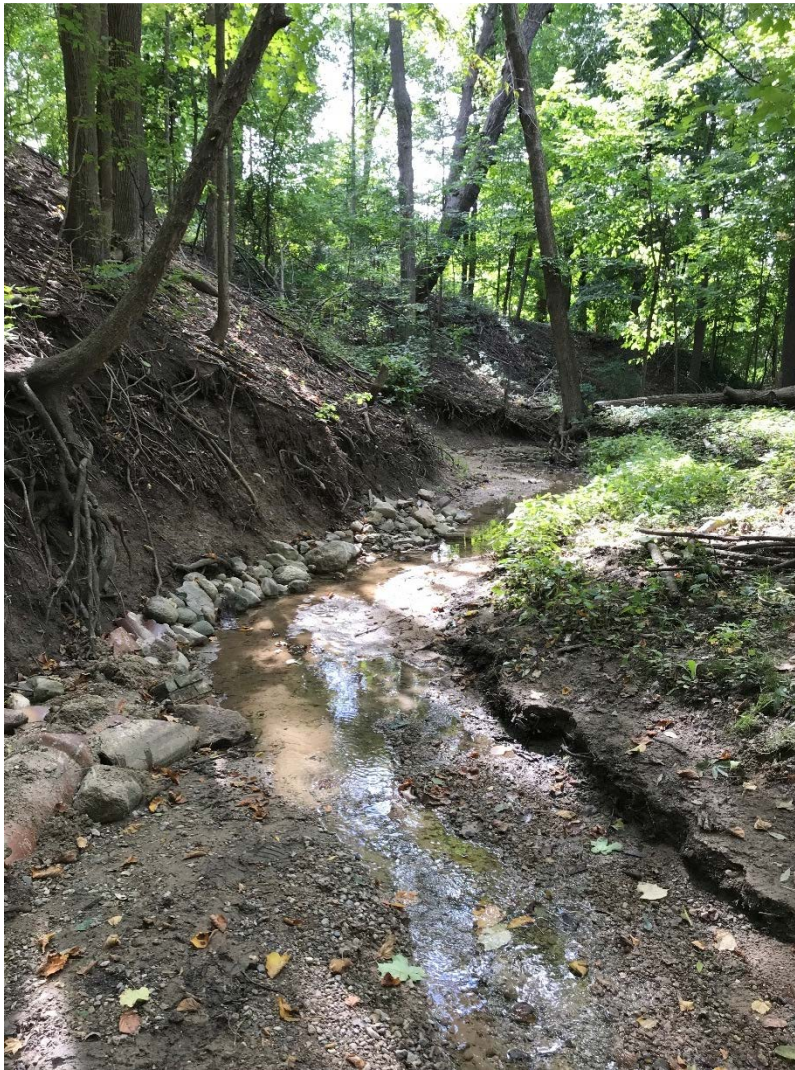
Figure 3 - Typical Upstream Ravine Drainage Channel – looking southwest from Barfield

Figure 3 indicates what was typically observed throughout most of the upstream open channel study reach. The width of the active channel represented in this photo measured out to be approximately 8.5 feet. It was very difficult to determine what the bankfull channel is in this reach due to the variability of geomorphic features that could be measured. This suggests that the water forces and flow rates that created the channel are likely very dynamic and changing and with that sediment loads are significant that a well-defined channel bankfull width and depth is difficult to document

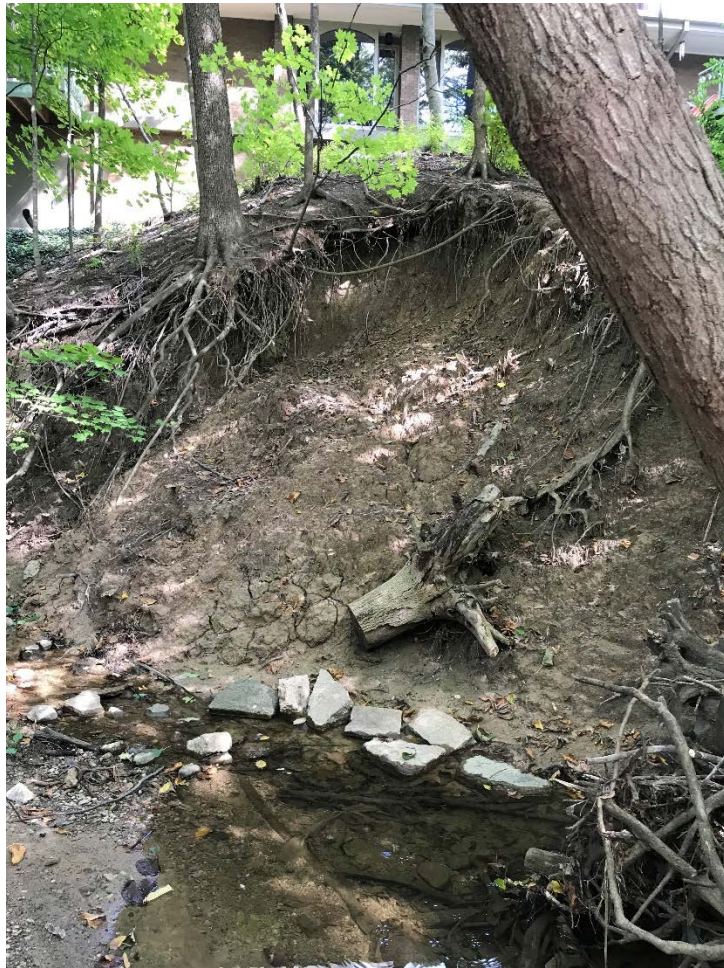
Figure 4 – Eroding Area behind the homes on Greentree Dr. SE.

After evaluating the entire length of the study area, there are areas that can be considered as stable as these bank areas are either reinforced by the existing vegetation or are areas hardened by boulders. The bank sections that were observed to be eroding are generally short in length and the sediment contributions from those reaches are very low. The sediment within the bottom of the channel appears to be relatively mobile and is passed by these stable areas by the flows. Boulders appear to have been placed in at culverts discharge areas to reduce storm discharge velocities as is shown on Figure 4 below.

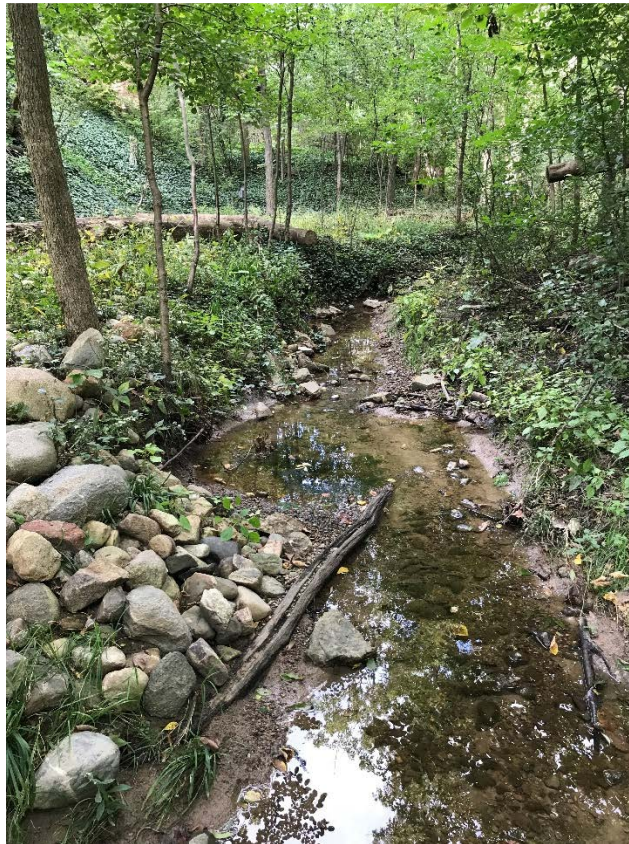
Figure 5– Stream banks and bed stabilized by heavy boulder installation

- Overall, the confinement of the stream is not an issue except where heavy boulder was previously installed which creates a threshold streambank (hardened) channel. Most of the residential homes that are riparian to the stream corridor have all been constructed up on the high terrace, well above the flood prone area and eroding channel.
- One home that was downstream of Barfield Road storm sewer outlet on the right bank is affected by bank erosion or failure due to stream bank erosion issues. Figure 3 is a typical picture of an actively eroding area that was observed.
- Generally mature native forest vegetation has established within the valley and there is evidence of surface soil erosion is occurring due to the lack of understory vegetation.

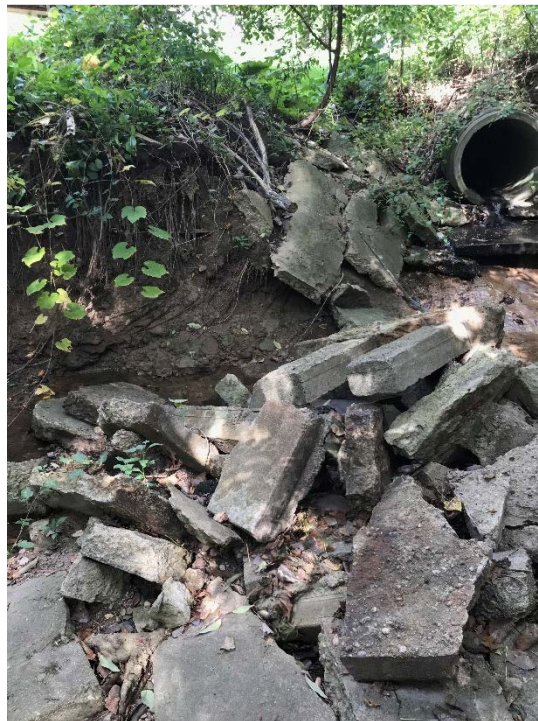
Stream channel immediately downstream of the 30-inch Culvert. The stream bed is extremely eroded at this location due to the steep bed slope. The flow works its way around the placed concrete debris.

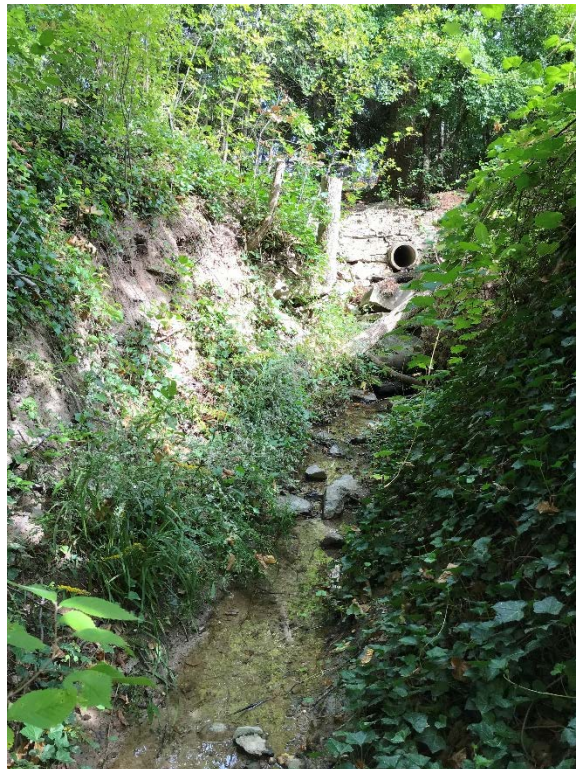
Capilano Branch 18-inch diameter outlet. Note that the stream has dropped several feet below the pipe invert due to historic erosion.

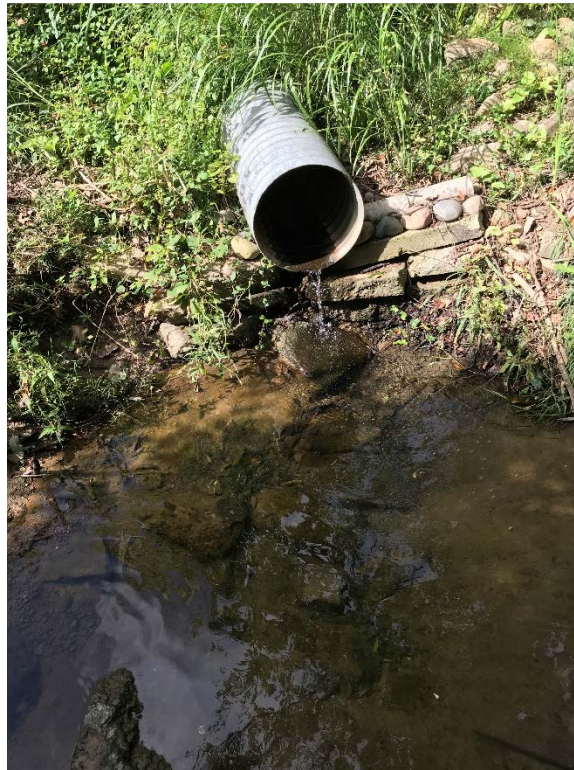
Glen Echo Branch entering from the west bank. This pipe enters perpendicular to the Main Branch and is eroding the near bank

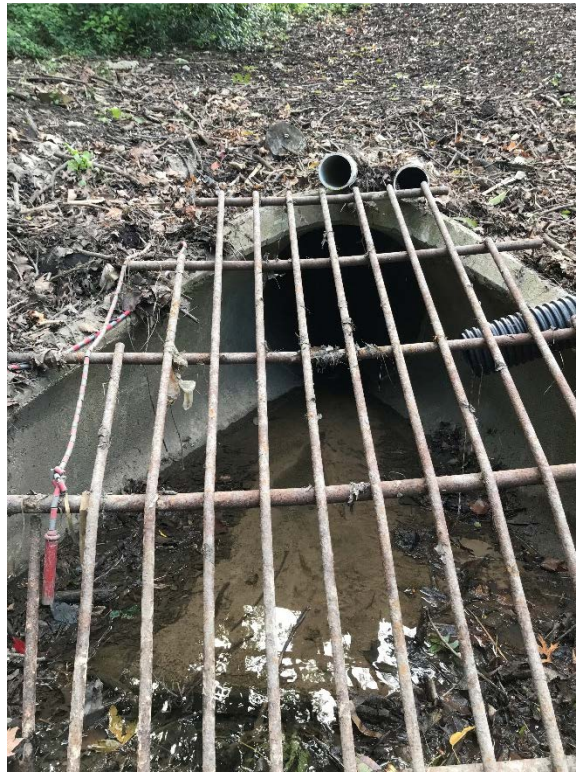
36-inch sewer upstream of Barfield Drive. This bar rack repeatedly plugs up with debris from trees.

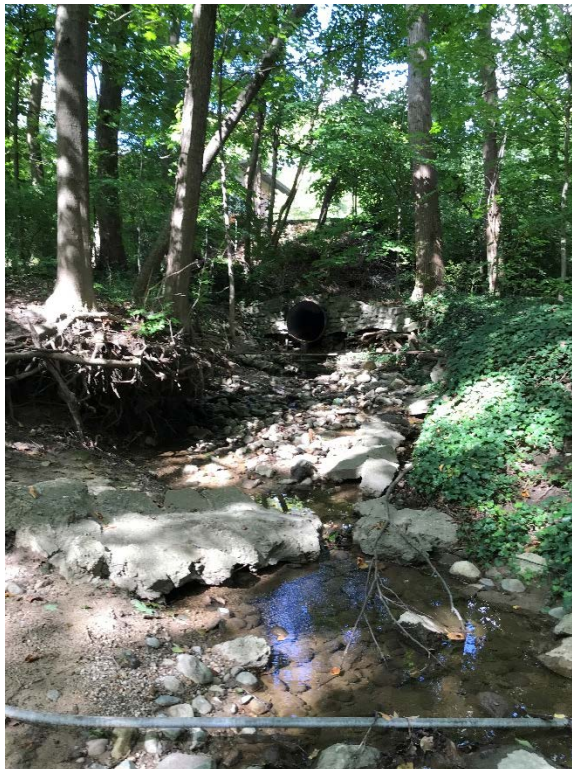
Downstream of Barfield Drive. Note severe bank erosion on bank.
Picture taken looking upstream.

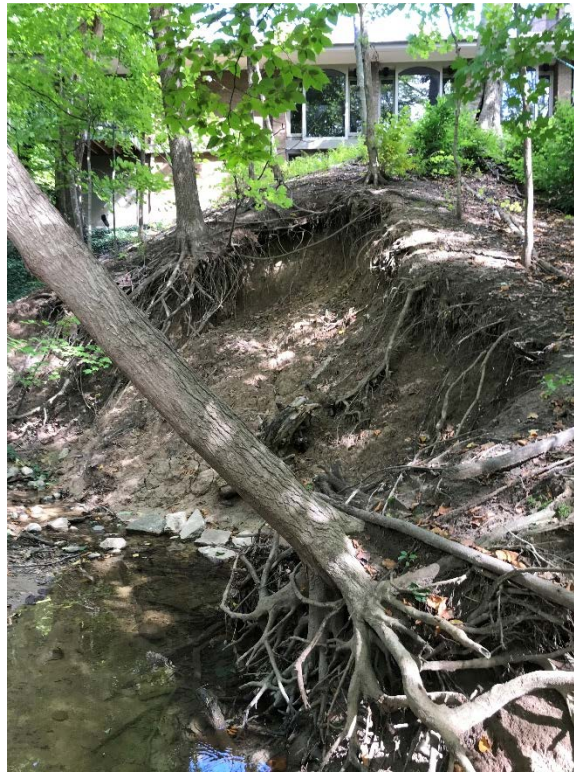
Highly eroded stream banks just downstream of Barfield Drive on the Left (SE)? Bank.
Picture taken looking upstream

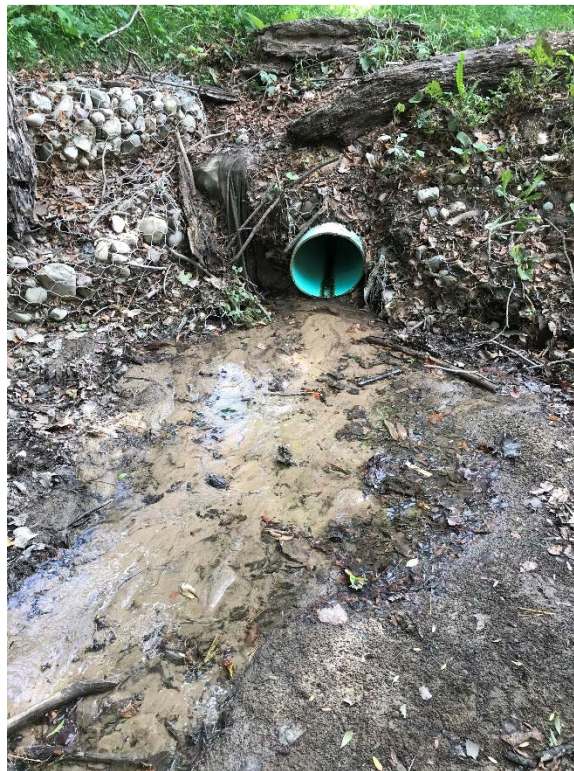
12-inch PVC sewer from Greentree Cul-de-sac upstream of triple 24-inch HDPE culverts.
Note that triple 24-inch culverts are buried with sediment just to the right of the 12-inch pipe.
Also note gabions baskets

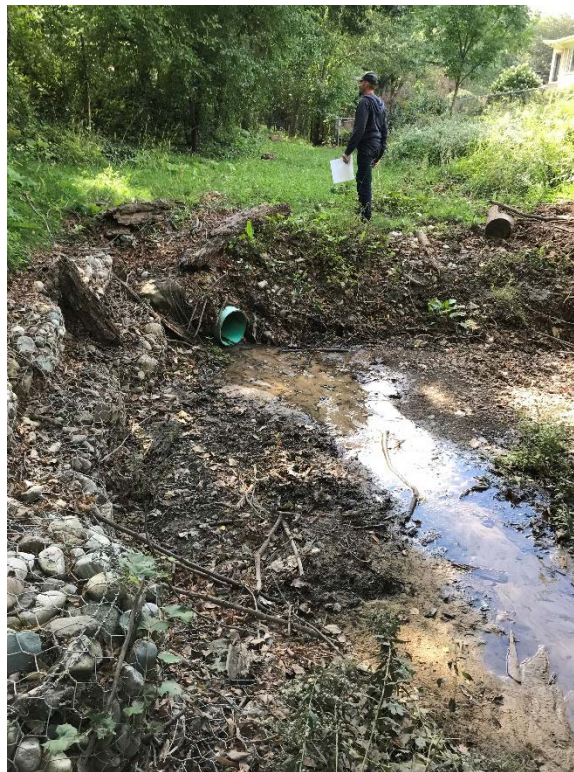
Looking downstream on the Main Branch from the triple culvert entrance. The grassed area is above the triple 24-inch culverts and experiences overland flow quite frequently.

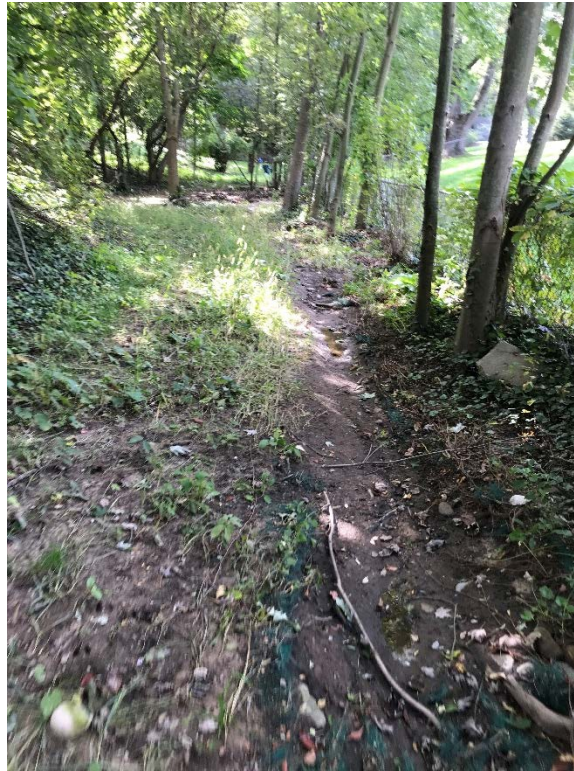
Looking downstream on the Main Branch about 100 feet downstream from the triple culverts entrance. This area is above the triple 24-inch culverts and shows evidence of overland flow quite frequently.

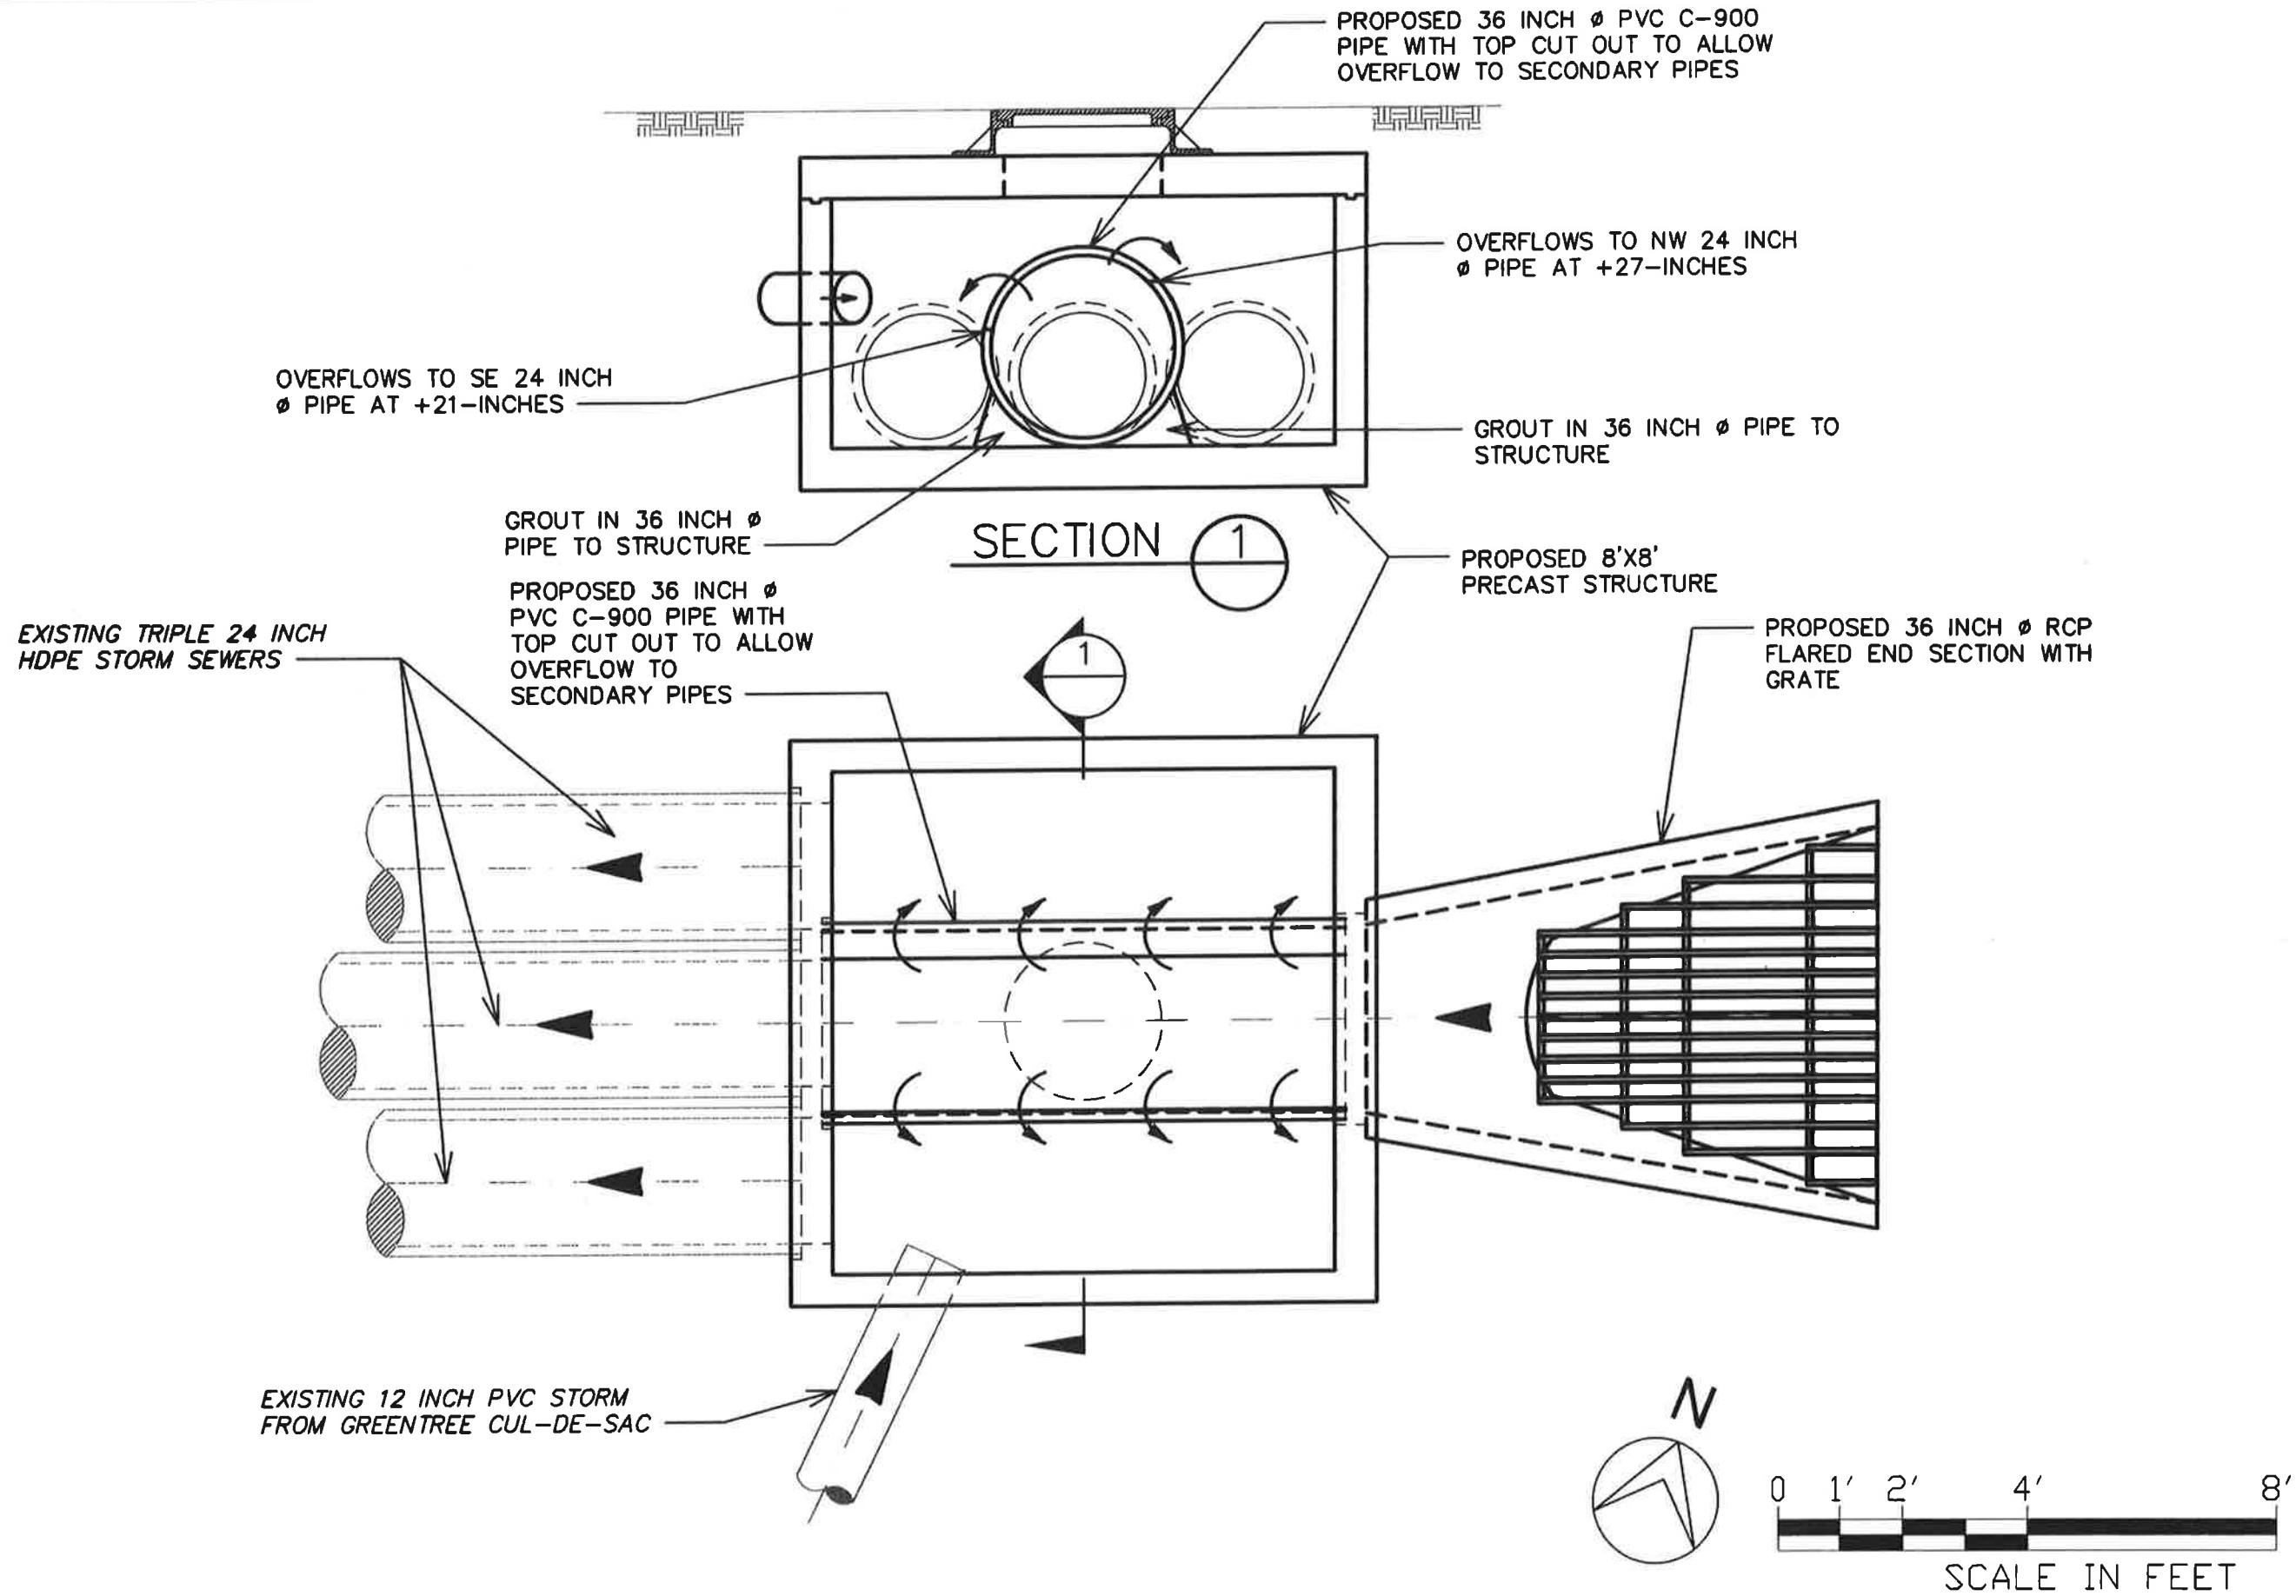
FIGURE NO.	6
JOB NO.	20180827
DATE	10/19/2018

It is recognized that, currently, the flow down the Glen Echo Branch is in excess of the capacity of these triple pipes fairly frequently and flows over land across the grassy area along the three lots to the downstream end of the culverts. Constructing the control structure discussed above would reduce the frequency of cleaning of these triple pipes significantly since cleansing velocity would be maintained in the center culvert and the side culverts would be utilized less frequently and only during higher frequency

At the upstream or inlet end of the triple 24-inch pipes, a control structure could be constructed to direct the normal dry weather flow through the center 24-inch diameter culvert. This would help ensure that the center culvert would be kept clean and in a good flowing state during most of the time since cleansing velocities would occur more frequently. Weirs could be installed within the control structure to overflow to the second and then the third pipes at progressively higher floors thus maintaining those two culverts in an available state to transport flow during moderate frequency events. This structure could also restrict flow slightly so as to optimize use of the channel upstream for storage and thus slow/reduce flows using center pipe for outlet thus keeping it clean and then overflow to other two and then over the top during extreme events.

events thus ensuring that they would experience flow through these side pipes only during high frequency events and thus they would likely be maintained in a cleaner state. A sketch of the upstream control structure is included in Figure 6 at the end of this report.
